THE MULTI-CRITERIA DIAGNOSTICS AND SURVEYS FOR UNDERSTANDING AND MONITORING THE ISSUE OF TECHNICAL RESTORATION IN THE TEACHING OF THE ARCHITECTURAL CONSERVATION

Giacomo Martines¹*, Olinda Ferrieri Caputi²

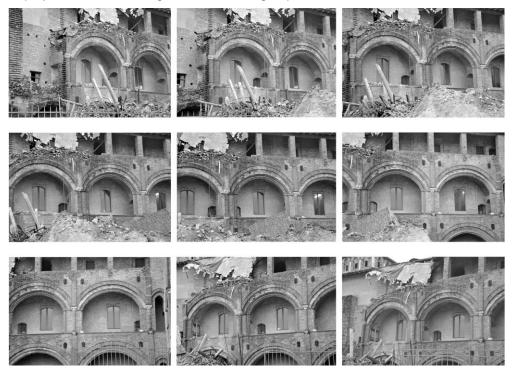
Fig. 1. Frames relative to the loggia of Finale Emilia Castle Fortresses damaged by the earthquake that hit

the Emilia Romagna in May of 2012 .

Fig. 2. Three-dimensional "collapse digital model" of the Finale Emilia Castle Fortresses loggia obtained with automatic development process (image matching) using the software 123D Catch by Autodesk by the students of the course: Maria Giovanna Rizzi, Serena Schiraldi, Gaia Spagnoletti, Graziana Tagarelli, Federica Vitarelli e Valentina Zaza.

A first approach to this method there was relief in the context of the collapse of the Fortress of Finale Emilia tower in the Emilian earthquake in 2012. The morphological characteristics of the product as a result of the earthquake and the accessibility conditions in addition to the limited time and available economic resources have made it the photo-modeling tool particularly suitable.

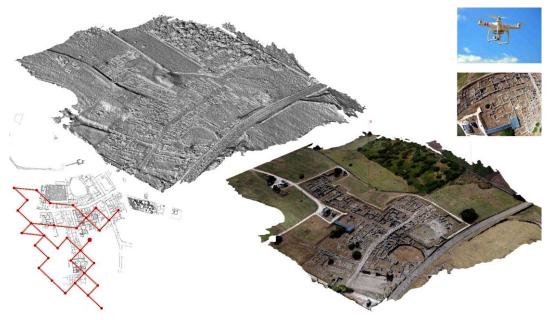
Fig. 3. Three-dimensional model merged and un-merged with chromatic data. the model shows clearly the soil microrelief and depressions. Model elaborated by the "pix4d" staff between the Photogrammetry Laboratory of the Polytechnic of Bari (geom. Pietro Grimaldi). Post production editing and interpretation by the students: Angelica Disabato, Vito Macina, Roberta Rita Maria Pinto, Virginia Polignano, Valentina Sica.

The Photogrammetric survey, this time produced by a Remotely piloted vehicle equipped for the remote sensing with a planned flight by gps control. The zenithal camera placed under the "drone" shot a series of ortogonal photograph of the soil.

In the postproduction work, the photographs were matched by specific software. This time the platform used was the "pix4d" solution due to the availability of the "pix4d software centre for Apulia", between the Photogrammetry Laboratory of the Polytechnic of Bari (geom. Pietro Grimaldi).

Through the aerial zenithally photograph and the 3d model of the archaeological soil, it was possible to analyse the condition of microrelief, humidity, plant differential grow that is used in the aero-archaeological field to indicate the presence of ancient building hidden underground. So the group of student was able to track some hypothetical plan of the unexcavated part of the city.
