## **A DEEP DIVE INTO THE CHRONIC AIR POLLUTION REALITY IN BAIA MARE: PART I: SOURCES OF HISTORICAL ENVIRONMENTAL POLLUTION IN BAIA MARE AND THEIR CONTRIBUTION TO AIR POLLUTION**

### **Abstract**

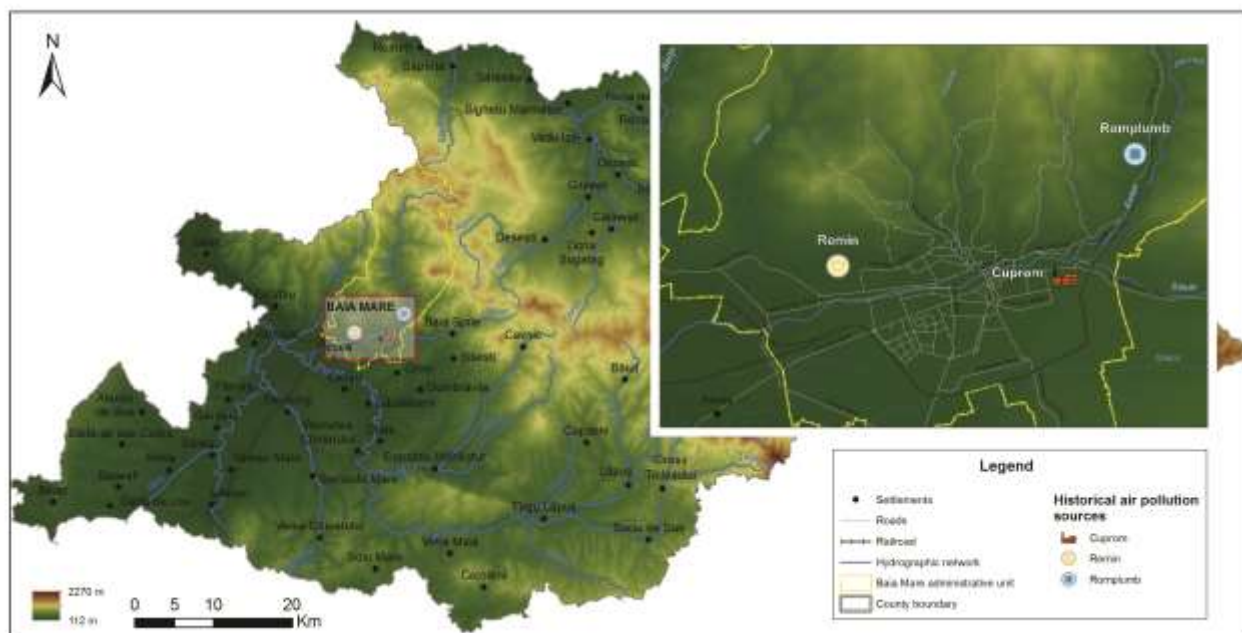
Baia Mare's historical environmental pollution (including air) had 3 main sources (Fig.1):

Fig.1. Baia Mare and its historical air pollution sources

Cuprom Corporation operations spanned over 53 ha and the company was based in Baia Mare's eastern industrial area (Fig.1). The company's main activity consisted of pyrometallurgical processing of copper and gold concentrates which resulted in the extraction of nonferrous metals.

With a total area of 15.6 ha, Romplumb Corporation operated in the northwest of Baia Mare (Fig.1), in a microdepression of Firiza Valley. The company's main activity was the pyrometallurgical processing of lead and copper concentrates in order to obtain decopperised lead. The company was state-owned, maintained continuous operation and, in 2006, employed about 750 (Romplumb website).
